DISCLAIMER: Second-Hand Plant Condition and Safety

Used Sale Safety & Compliance Check

MHE-000130 / 124181 / Harry Lim / 08/01/2026 / Jungheinrich /
EFG218ki

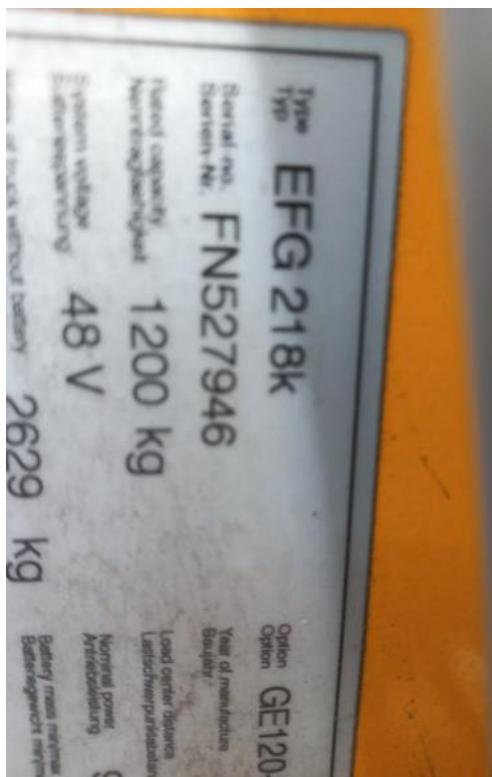
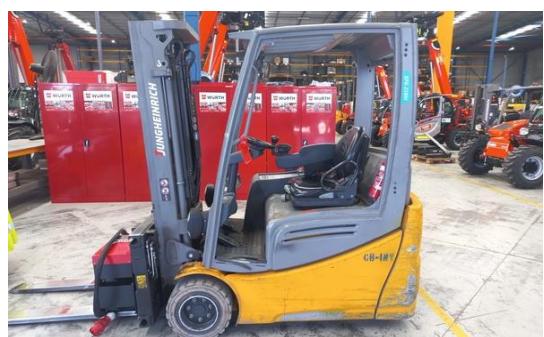
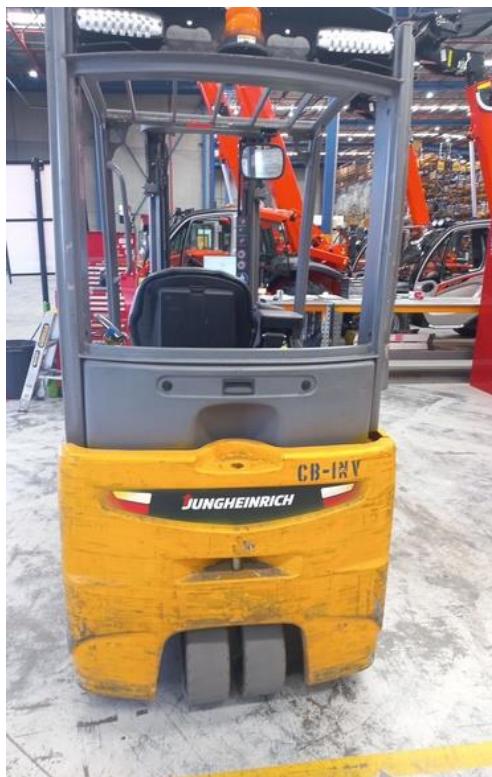
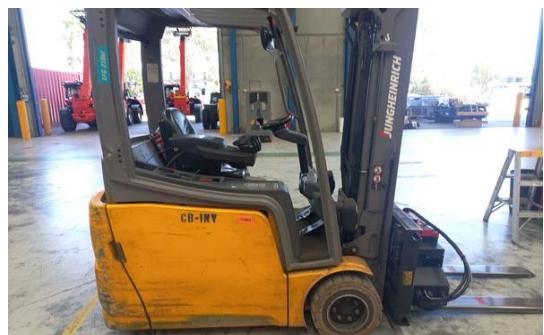
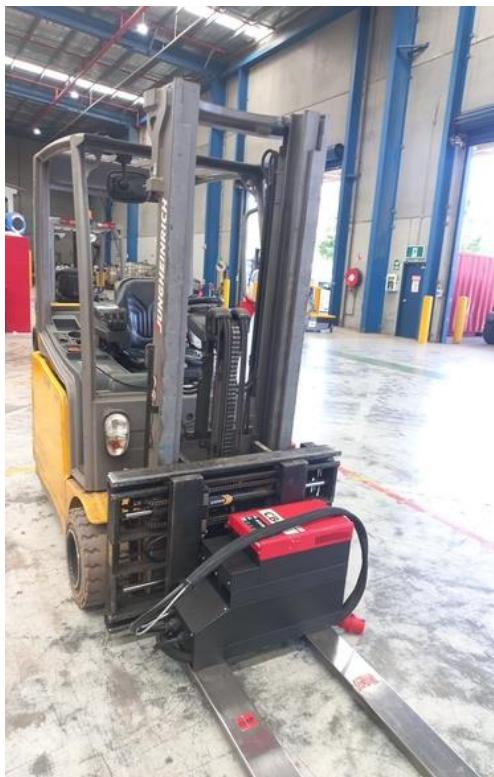
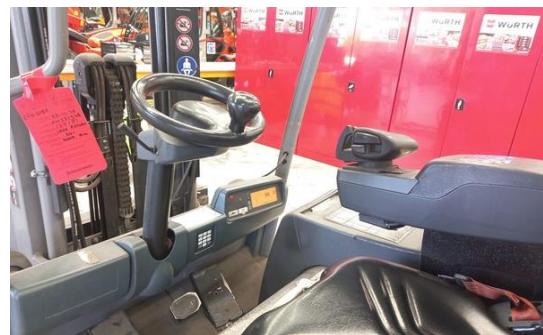
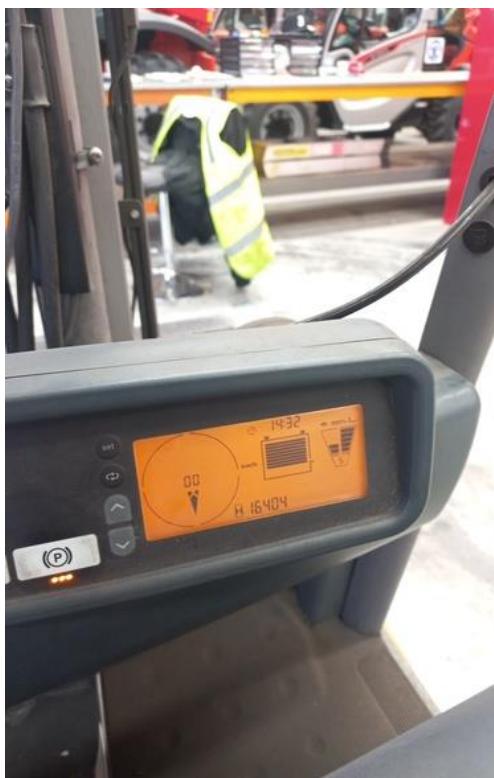
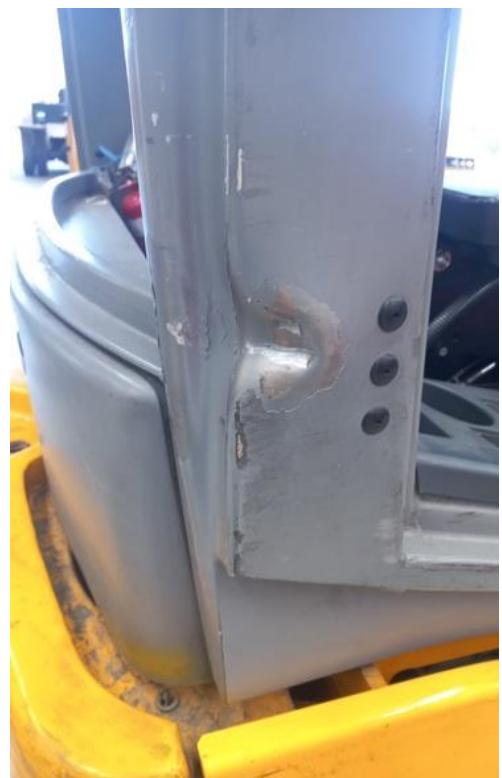
Over head guard damage
Tow pin damaged

Overhead guard damaged.
Tow pin damaged.
L/H Extender tyne cylinder rod bent.
Rear tyres required.
Front tyres required.
Front rims scuffed.
Sensor pole brackets bent.
Charger not tested, Fitted with euro plug.
Forklift fitted with aftermarket battery

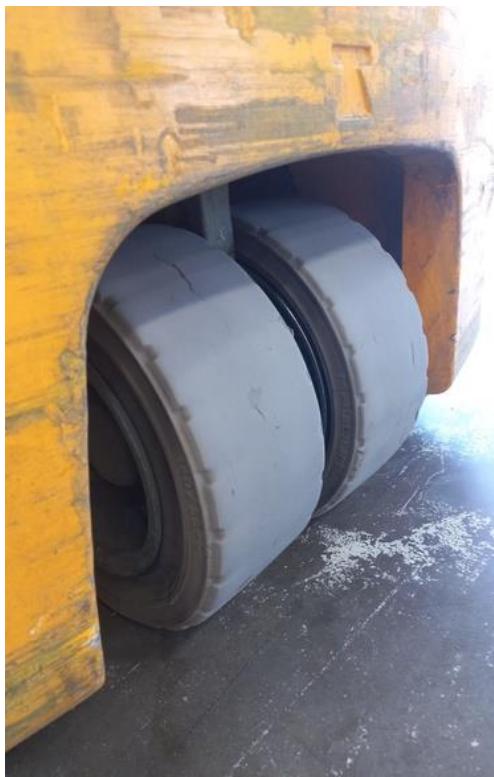
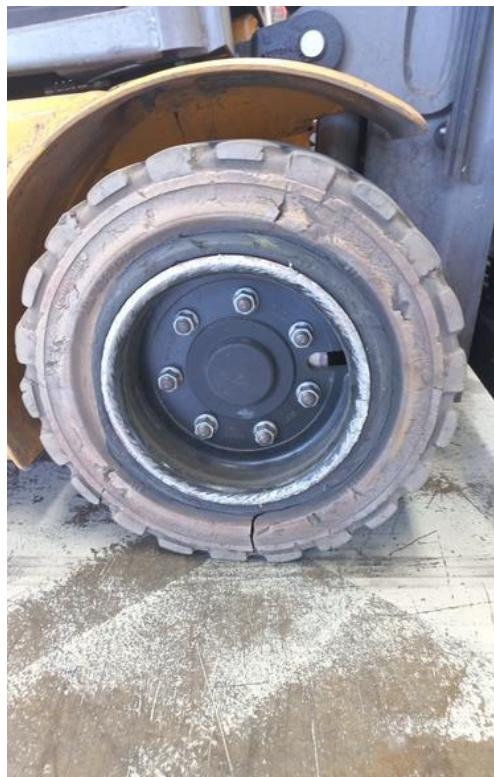
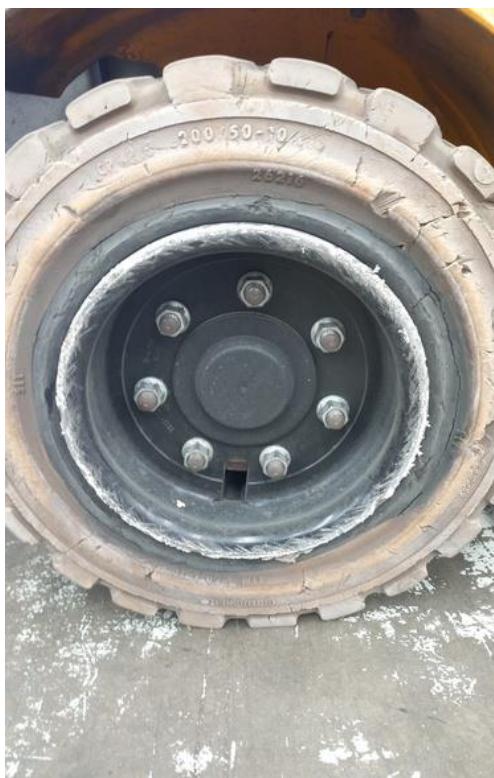
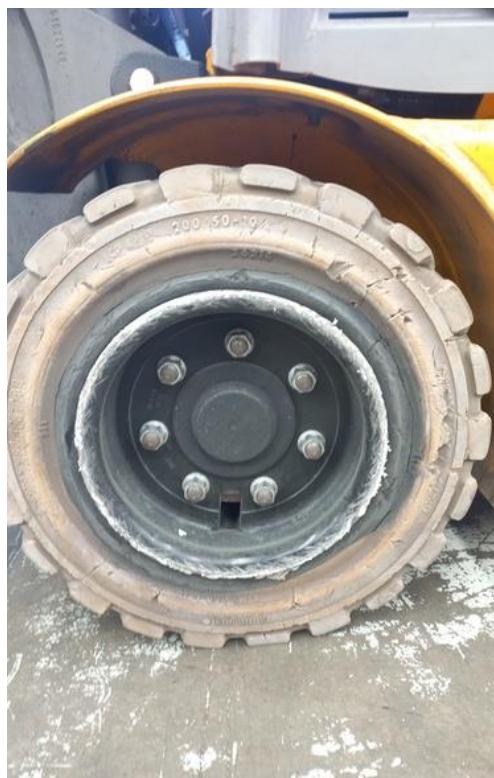
Rear almost on limit
Front tyres scuffed and starting to delaminate
2 x front wheels scuffed

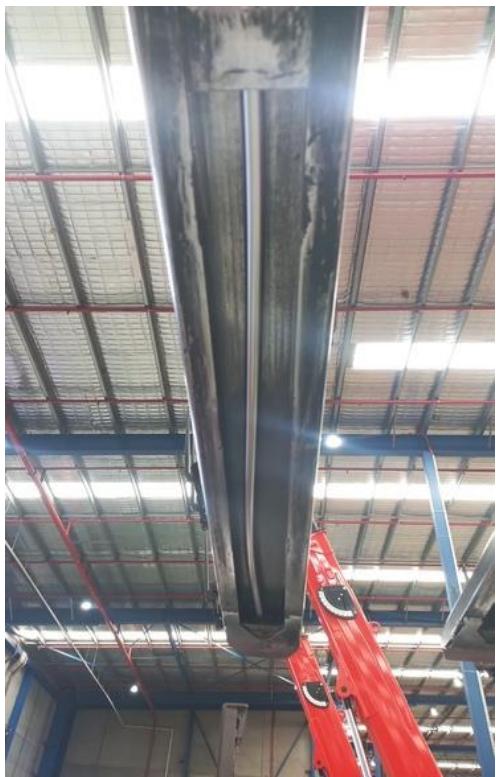
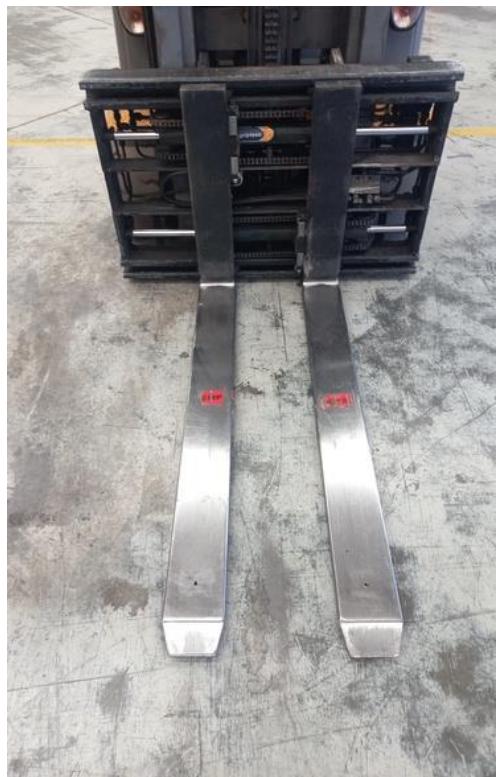
L/H extender tyre cylinder rod bent
