# HYDRAULIC TRUCK CRANE

## Maintenance List

HTC A 174955-12

## Grove TMS9000E

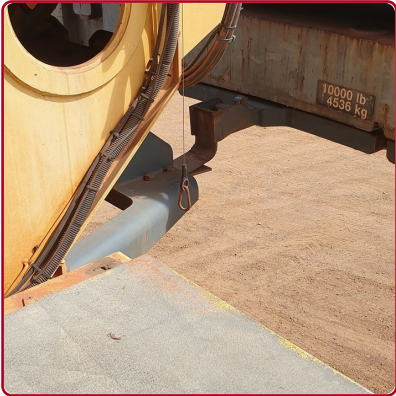
Boom Length Recoil Drum(s)

NOT OK

Precision length reel is seized

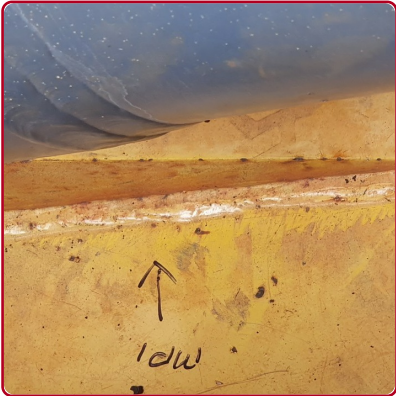
Boom Mounting Lugs

NOT OK

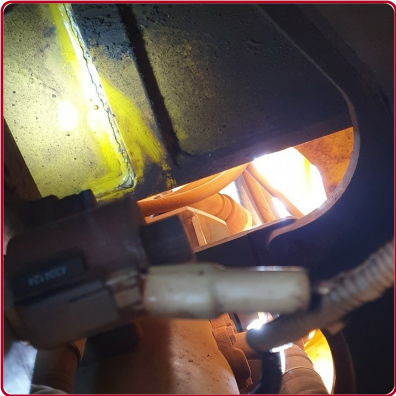
Lift Cylinder Lugs

NOT OK

Cracked underneath

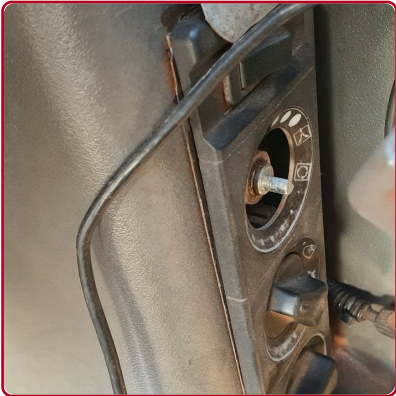
Air Conditioner

NOT OK

Not working

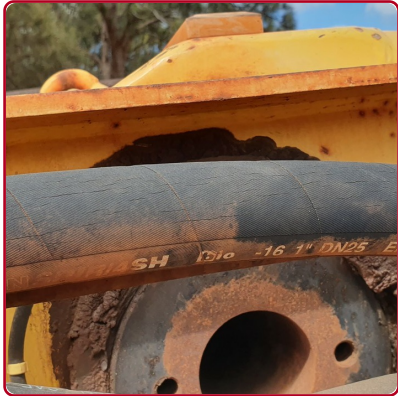
Suction Lines and Hoses

NOT OK

winch hoses are perished

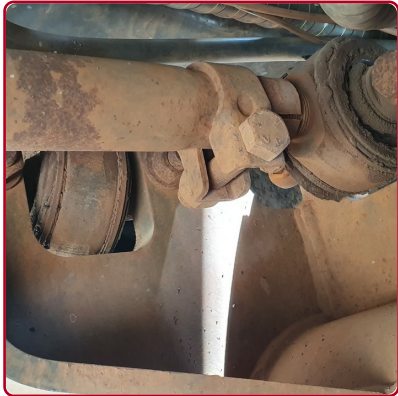
Steering Components

NOT OK

Front left hand torque arm rear bush is perished

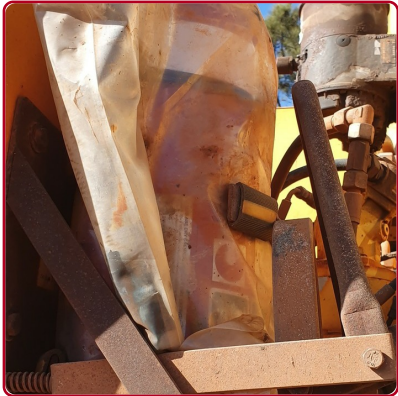
Fire Extinguisher

NOT OK

vessel older than 5 years

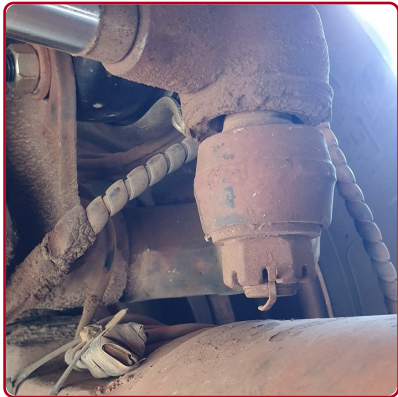
front left hand steering cylinder tie rod end bushes are perished

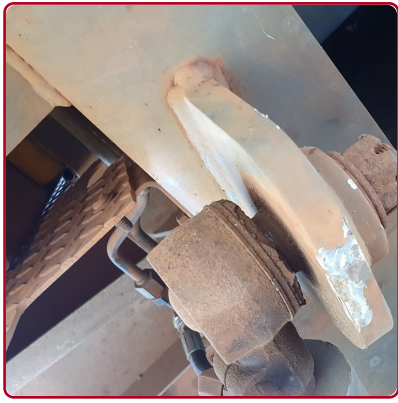
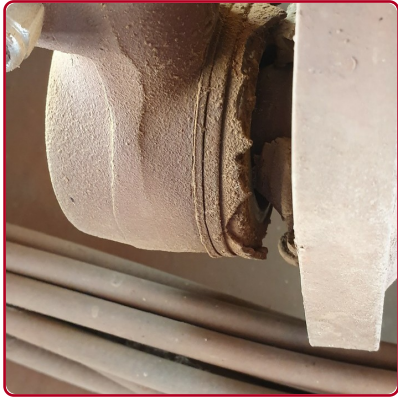
2 nd axle steer cylinder tie rod ends are perished

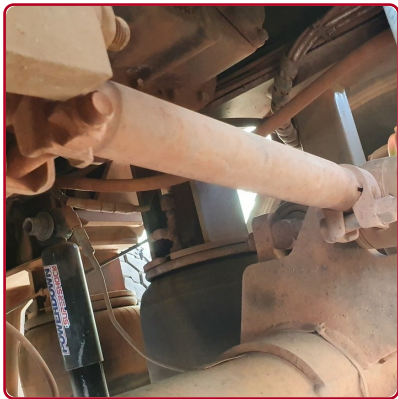
tie rod ends chassi to 2nd axle torque arm

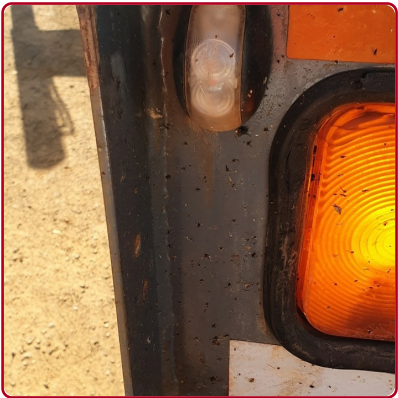
Clearance Lights

NOT OK

Left habd park light

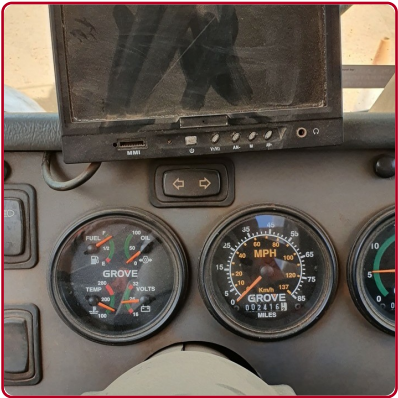
Reverse Camera

NOT OK

Not working

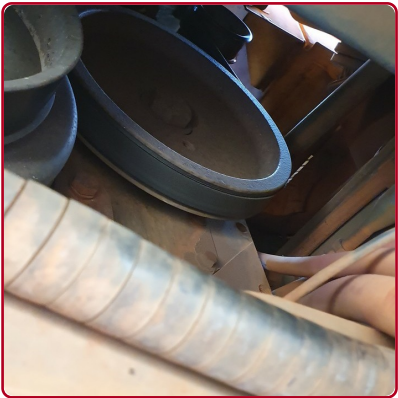
Power Transmission Belts

NOT OK

Airconditioner belt is loose

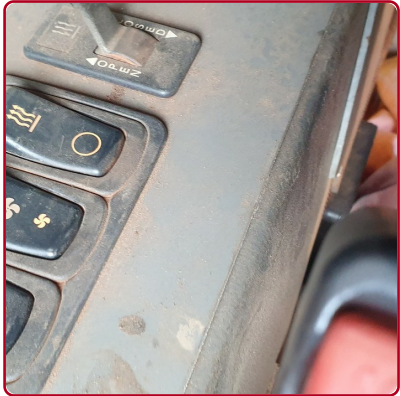
Heater

NOT OK

not warm

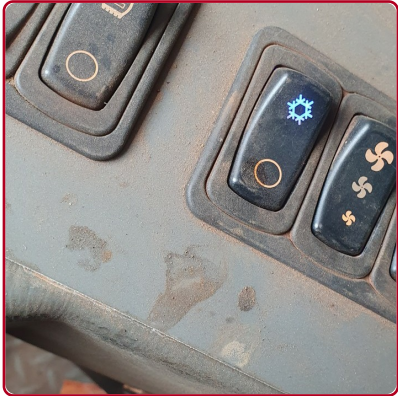
Air Conditioner

NOT OK

Not cold

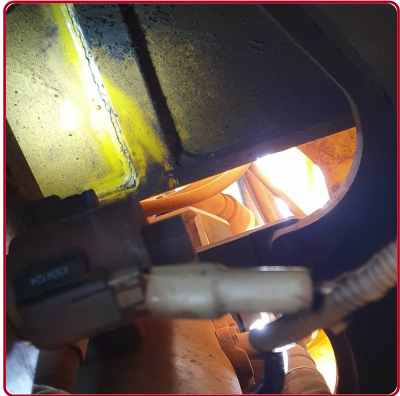
Crack Inspection

NOT OK

under slew turrett
