PRE-PURCHASE SURVEY FOR

19/10/2022

DREW SAYER
FORE AND AFT SURVEYORS
PH: 0419 042 558 ABN 95806 164059
WWW.FOREANDAFTSURVEYORS.COM
GLENWOOD QUEENSLAND 4570

VESSEL: Foxy Lady **DESIGN:** Mariner 31 **REGISTRATION:** DL103Q

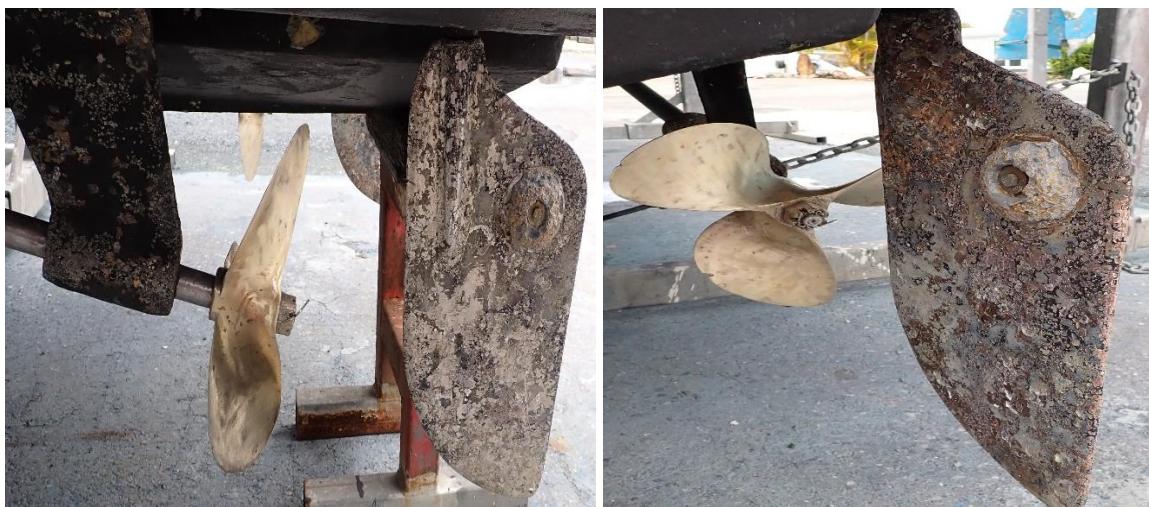
There are two three-blade bronze propellers mounted on 1 ¼ inch stainless-steel shafts. The cutlass bearings felt firm when I rotated the shafts by hand.

There are two free standing rudders. Both rudder bearings felt firm when I moved the rudders by hand.

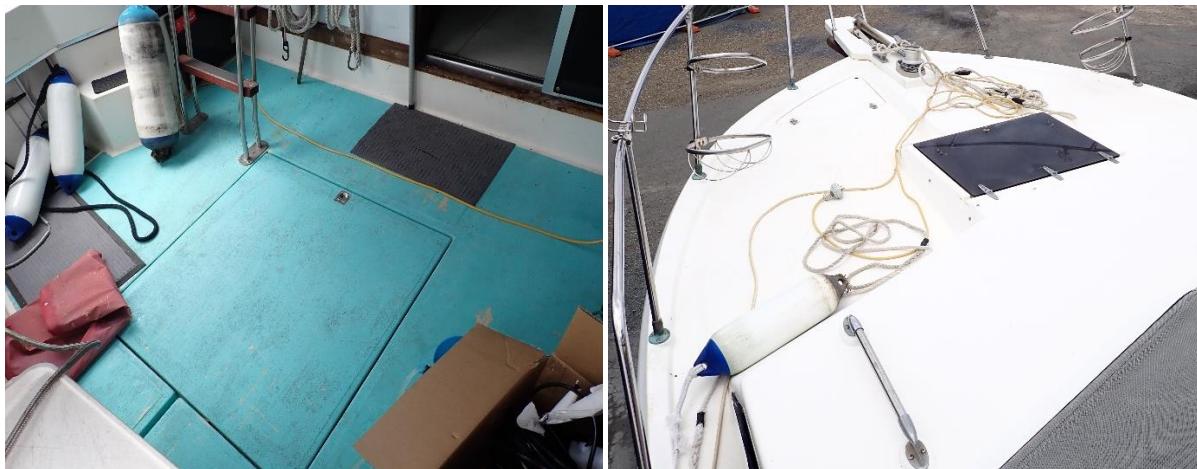
The fiberglass deck is in average condition for a 13-year-old vessel. A random percussion test found no soft spots on the day of the survey. The paint on the cockpit floor is due to be painted again.

The cabin windows are safety glass in aluminium frames and look in good condition. The exterior window shades are due to be replaced.

1. Replace exterior window shades.

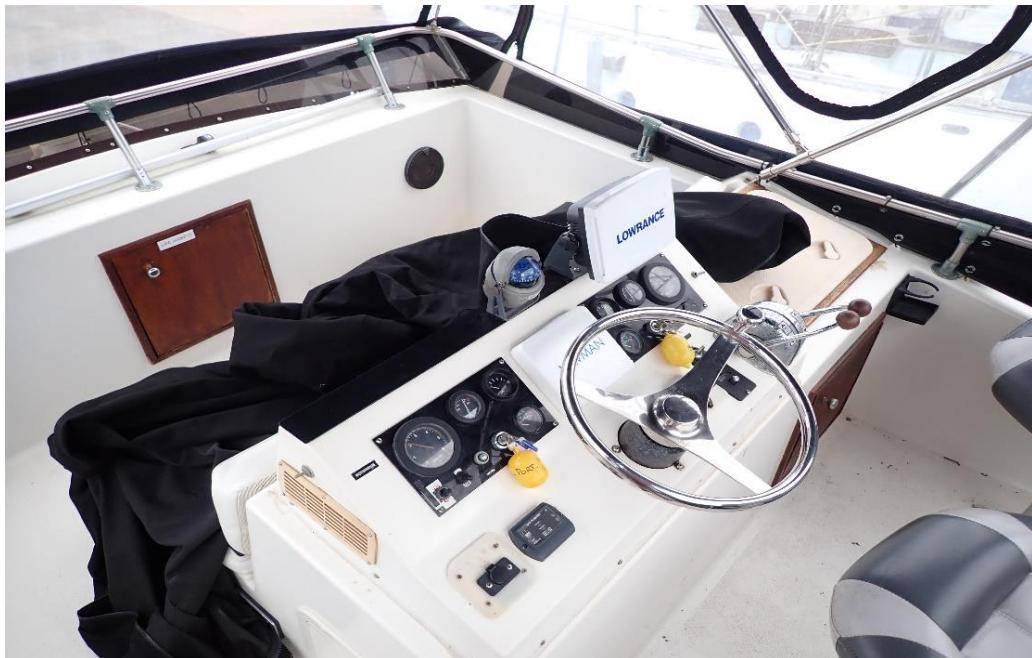
There is a black canvas Bimini with clears and stainless-steel uprights that covers the whole fly bridge area.

The twin lever engine controls and instruments are all within easy reach of the two helm seats.

The clears could do with a clean.

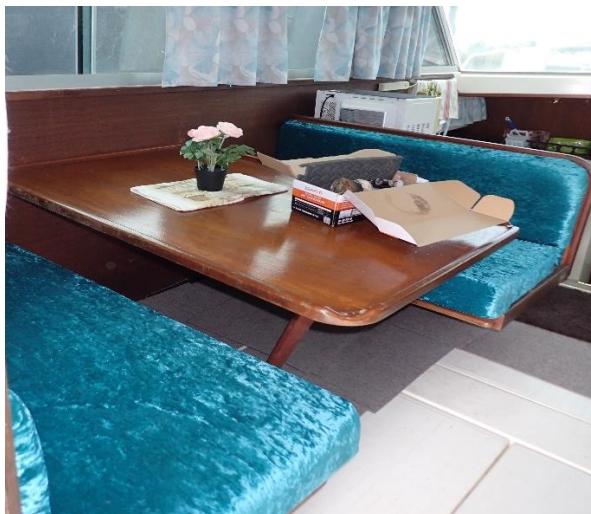
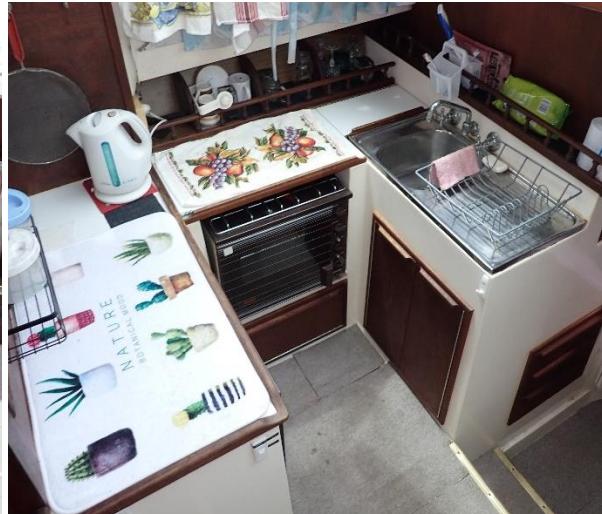
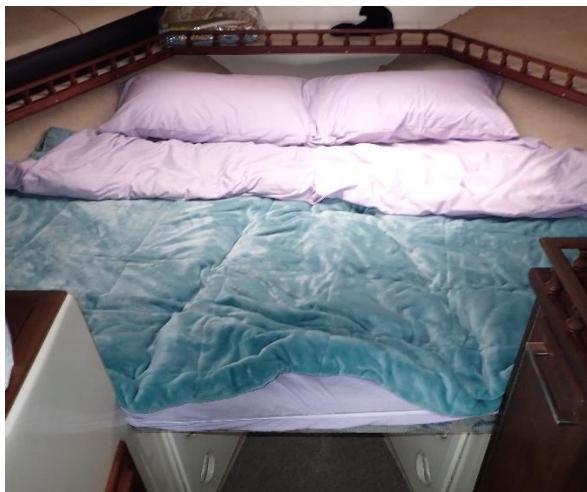
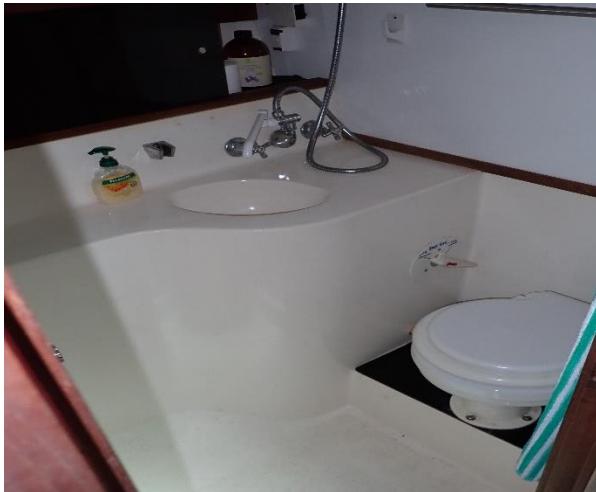
The interior is finished in white gelcoat, varnish trim and panels and blue upholstery. The interior is in average condition for a 38-year-old vessel.

The photos starting from the left-hand side and going clockwise are dinette, galley, toilet/shower, compartment and bow berth.

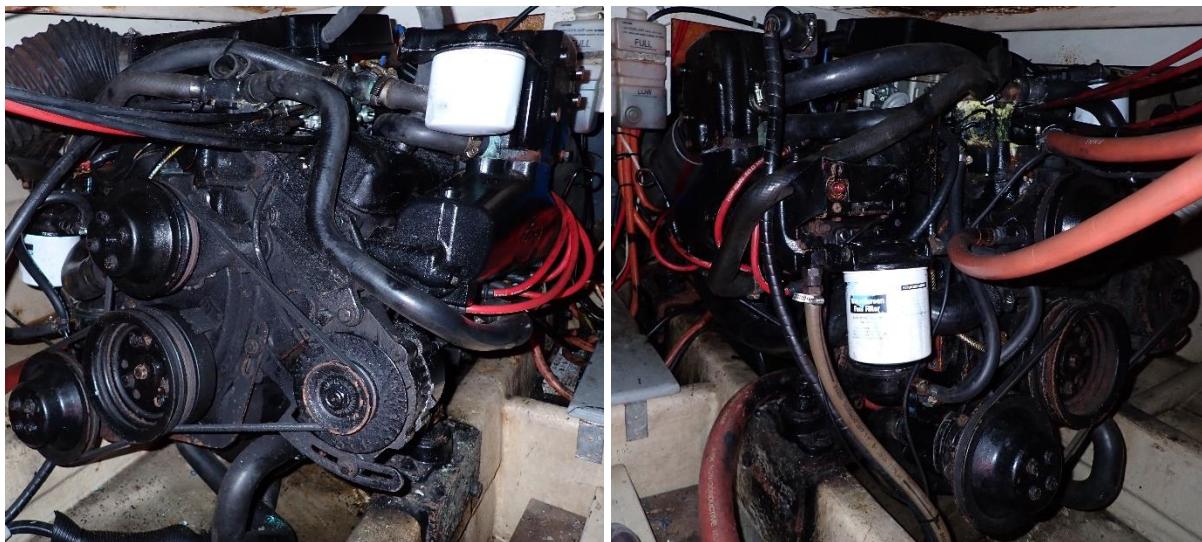
The engine inspection was a visual one, so I am unable to comment on the condition of the internal parts or the correct operation of the engines. There are two 220hp V8 Mercruiser 5.0L petrol engines mounted under the cabin sole. There are approximately 1484 hours on the port engine and 1492 hours on the starboard engine. There is a grease seal fitted on each shaft. The engines have just had a full service.

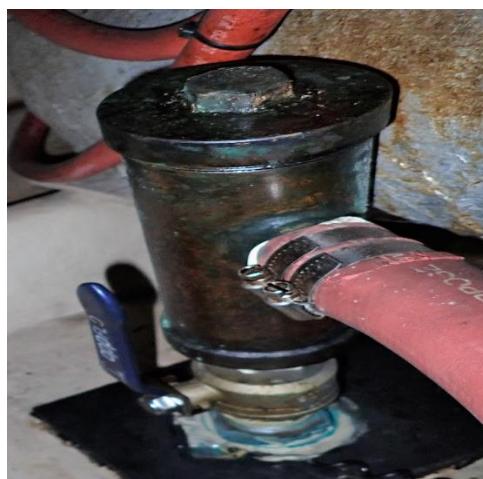
The hydraulic steering is in good condition and the rams is easily accessed through the aft deck hatch.

The seacocks all open and close easily.

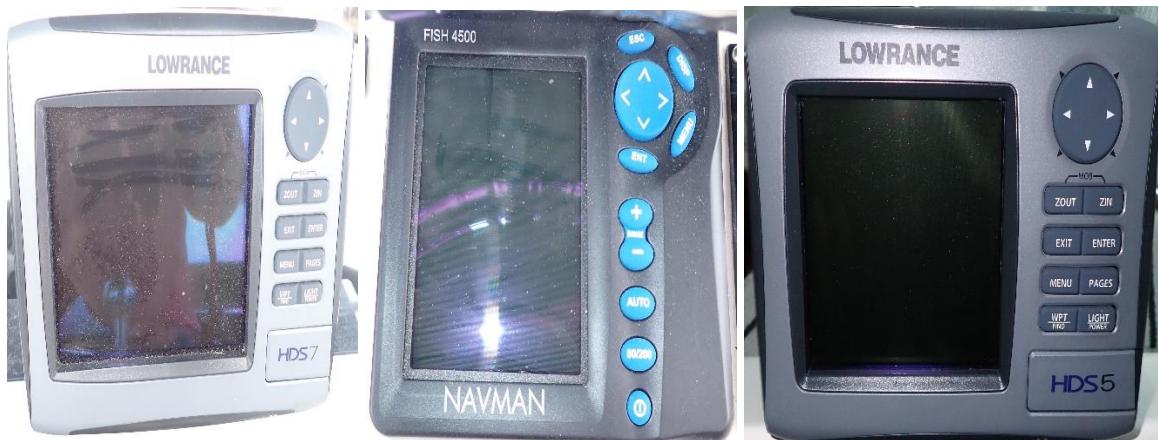
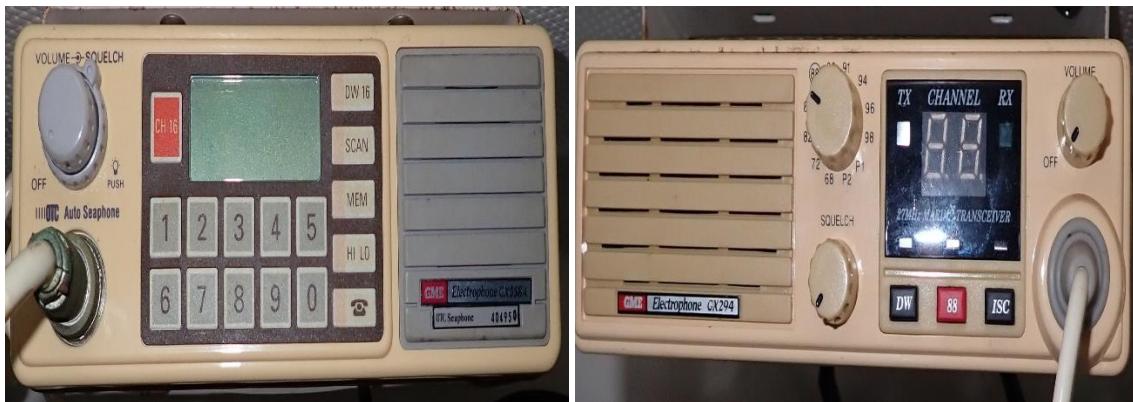
The 12-volt electrical installations are all fitted with fuses which appear to be functioning correctly.

There are four AC Delco batteries and one Exide battery in the bilge.

There is a Lowrance HDS7 plotter, Navman Fish 4500 fish finder, Lowrance HDS5 plotter, GME VHF, GME 27 meg, solar panel and regulator.
