## **SURVEY REPORT**

At the request of John Dutch (Client)  
of 4 Idlewoods Cr. Rainbow Flat NSW 2430, RMS carried out an 'out of  
water' pre purchase condition survey, at Marks Point Marina (Location of  
vessel) on 10<sup>th</sup> November 2021 (Date of inspection).

<b>Name:</b>	<b>Ambassador 1</b>
<b>Model:</b>	<b>Gulf Craft Ambassador 38</b>
<b>Hull material:</b>	<b>GRP</b>
<b>Hull colour:</b>	<b>White</b>
<b>Designer:</b>	<b>Gulf Craft</b>
<b>Builder:</b>	<b>Gulf Craft</b>
<b>Launched:</b>	<b>1995</b>
<b>LOA:</b>	<b>11.6m</b>
<b>Beam:</b>	<b>3.7m</b>
<b>Draft:</b>	<b>.9m</b>
<b>Displacement:</b>	<b>Approx 5.5 tonnes</b>
<b>Registration/HIN #</b>	<b>AUWWA159144HT8</b>
<b>Waterways #</b>	<b>AFG898N</b>

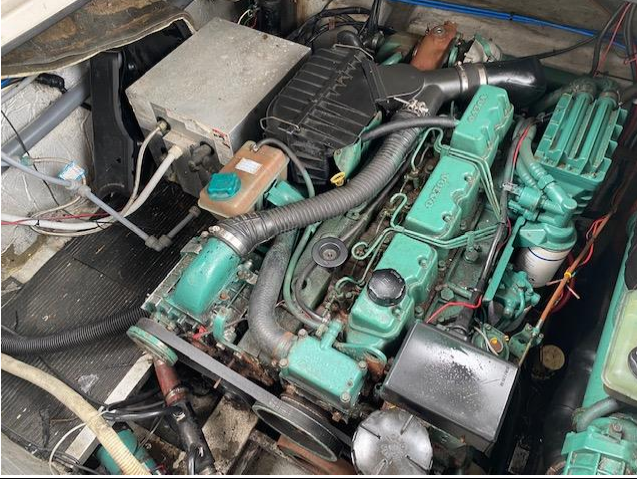
**7. Volvo diesel**

Item
<p>Volvo Penta KAD42 Twin diesels 230Hp stern drives S/N 2204210674 (port) and 2204210548 (stbd). Gauges operational. Trim tabs and tilt operational. Hourmeter showing 140 Hrs. Horn &amp; blower not working, wipers operational. Overall condition of the engines appears in reasonable order however this is not a complete mechanical survey and should be used as an indication only. If further information s required a complete survey from a marine mechanical engineer should be obtained. On sea trial the vessel achieved 14.5 knots @ 2300 rpm. Black exhaust smoke and steam showing. Supercharger was 'hunting'. Suggest a full service be performed on the engines.</p> <p>Onan generator operational</p>

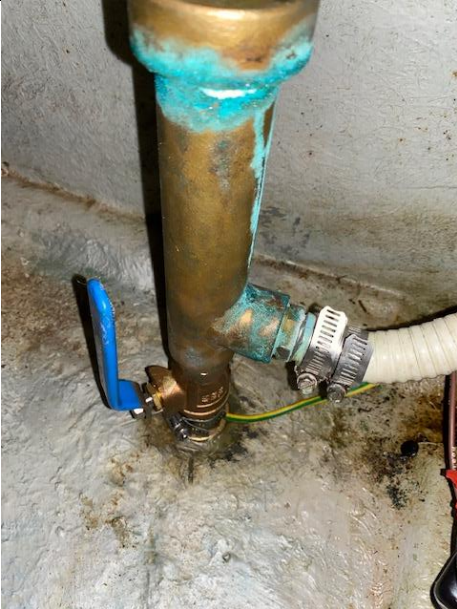
**9. Ball valves**

<b>Item</b>	<b>Description/Condition</b>
<b>Transducers</b>	Depth operational
<b>Seacocks/operation</b>	Ball valves all replaced and serviceable
<b>Pumps</b>	2 electric with float switch, 1 shower sump and 1 manual bilge pump all operational
<b>Toilet</b>	TMC electric toilet with macerator operational
<b>Tankage</b>	2 Aluminium fuel tanks with shut off valves 800 litres, 270 litre aluminium water tank, 25 litre HW tank

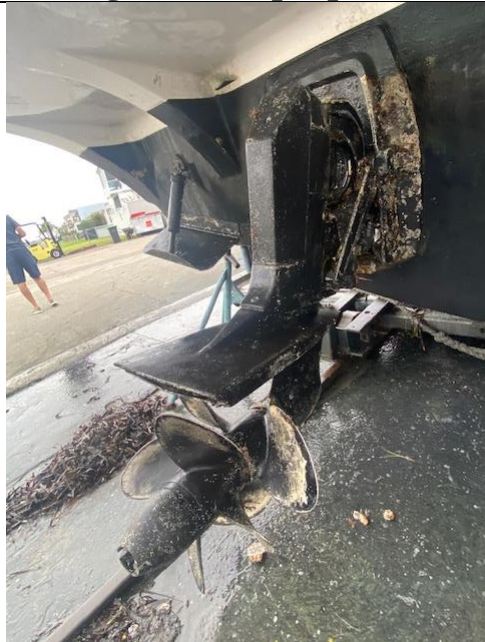
<p><b>17. Leg and duo prop</b></p>

<b>Item</b>	<b>Description/Condition</b>
<b>Rudder / Wheel</b>	Sports wheel in good condition
<b>Cables and Sheaves</b>	All appear in serviceable condition
<b>Propeller</b>	Volvo 290 Duoprops (3 and 4 blade props) in satisfactory condition
<b>Struts and Skegs</b>	All appear in satisfactory condition
<b>Bearings</b>	Gimbal bearings appear serviceable
<b>Emergency steering</b>	none

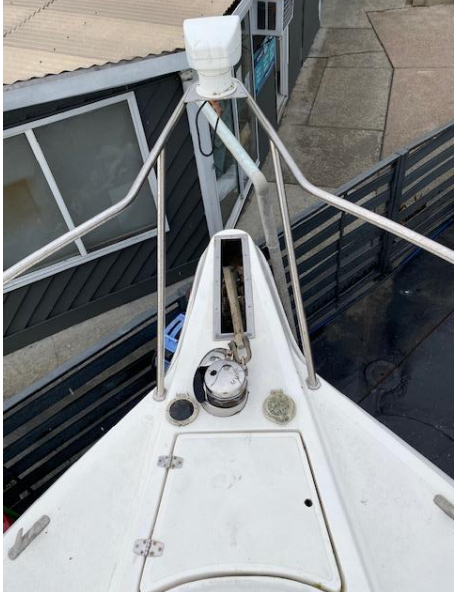
<b>19. Foredeck, spotlight &amp; ground tackle</b>	<b>20. Foredeck</b>
