Marine Survey Report

**Insurance Evaluation
For The Vessel
“45 ft Timber Houseboat”**

Survey Report Date - 12th February 2016
Prepared Exclusively For The Owner
Philip & Lauren Foster
Phone – 0420 411 722
Email – tweedcoastmotorcycletyres@gmail.com

This vessel is a large volume **45 ft Timber Houseboat Registration No – QF256Q**, the two hulls have been constructed from good quality timbers and marine plywood overlaid with layered GRP. The superstructure is timber framed and marine plywood sealed with layered GRP. Powered by a pair of new 60 horsepower Yamaha four stroke outboards giving a cruise speed of approximately 6.5 knots. The interior consists of a good size lounge / dining area, full size galley, double cabin with built in robes, single cabin with built in robes and the forward helm station with port and starboard side doors. The upper deck has a lounge atop the stairwell, a rear BBQ entertainment area and a forward sun deck area. The vessel is ideally suited for extended vacations or as a live-aboard houseboat.

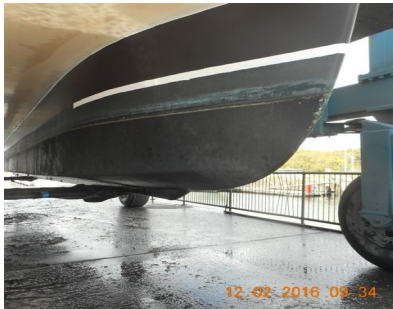
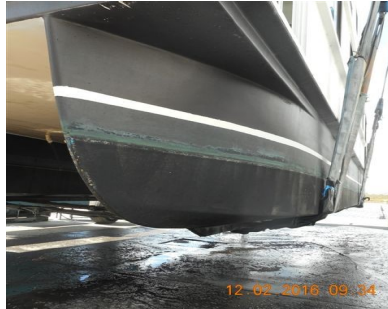
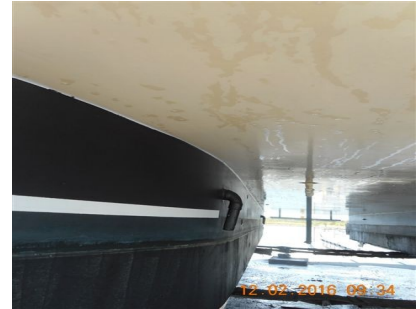
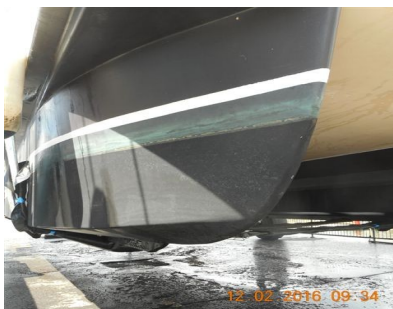
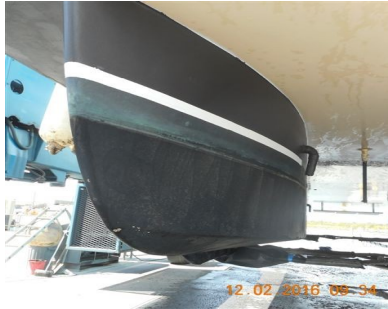
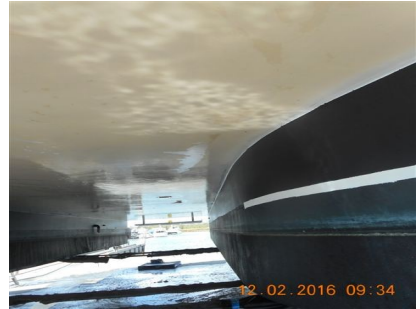
Comments & Recommendations : This out of water was performed on the 12th February 2016 at approximately 9.30am. The vessel was found to be in a good condition with no defects noted at the time. The vessel has attached aluminium transom pods to house the two new 2014 model Yamaha 60 horsepower four stroke outboard motors. The pods have been professionally built and installed to a high industry standard.

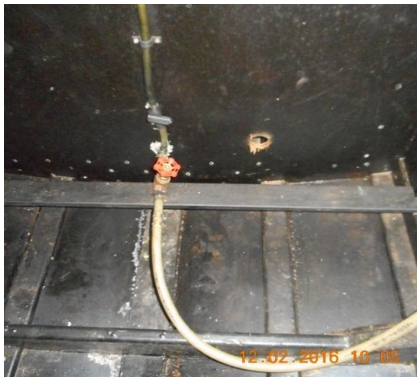
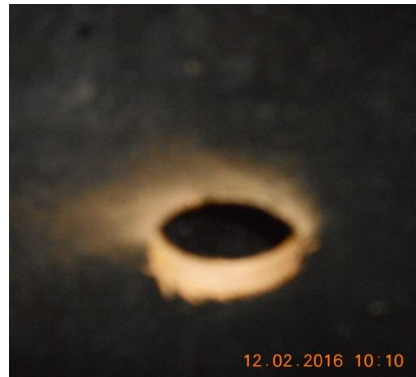
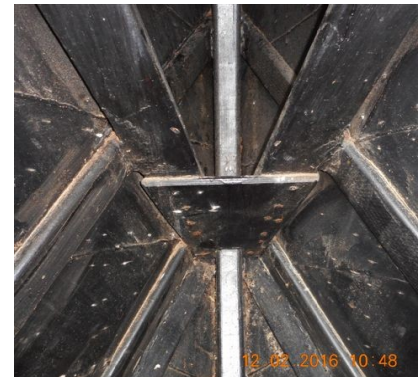
Comments & Recommendations : The internal inspection of the two hulls relieved the hulls to be in very good condition with no defects noted. The timbers are in sound condition with no deterioration detected and all the bonded joints and fastened section free from defects. It was noted that there are 5 separated bulkhead sections within each hull that are watertight and access to each section is achieved through a manhole atop the hulls. A portable bilge pumping system is available and stored on board the vessel to be used in case of an emergency.

N/B - It was noted that a single hole of approximately 50mm in diameter has been made in each bulkhead on both the port and starboard hulls. This hole compromises the watertight integrity of the vessels bulkheads.

It is the recommendation of the undersigned surveyor to seal the holes in all bulkheads. In addition, there are a couple of service penetrations through the bulkheads that require the application of an approved sealant (Sika-flex or similar) to reinstate the bulkheads watertight integrity.

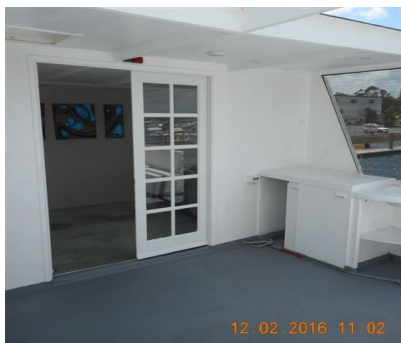
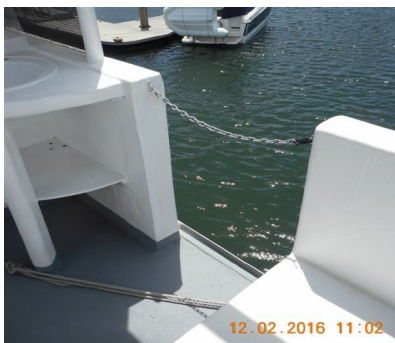
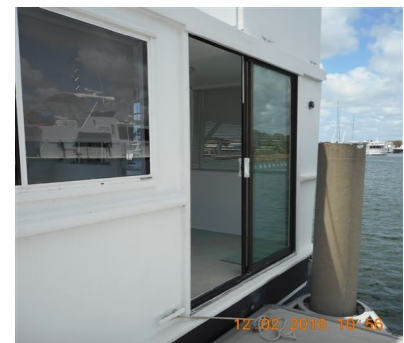
N/B - It was noted that the upper deck side openings have a single safety chain fitted that is considered mildly acceptable. It is the recommendation of the undersigned surveyor to fit gates to these openings for added safety.

N/B - It was noted that the lower deck sliding door side openings allow unrestricted direct access to the water. It is the recommendation of the undersigned surveyor to fit gates or removable barriers to these openings for added safety.

N/B - It was noted that two windows on the lower deck and one window on the upper deck are cracked. **These windows require repair.**

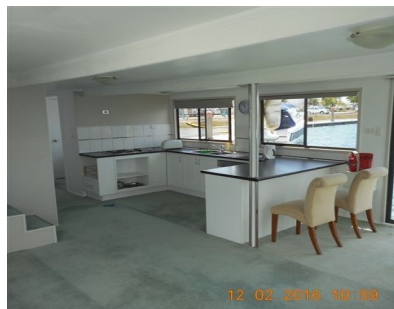
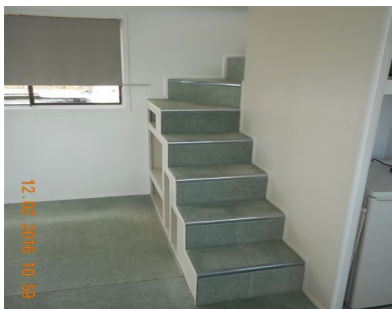
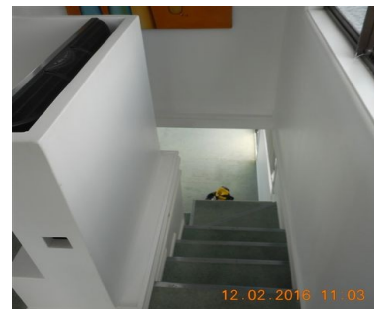
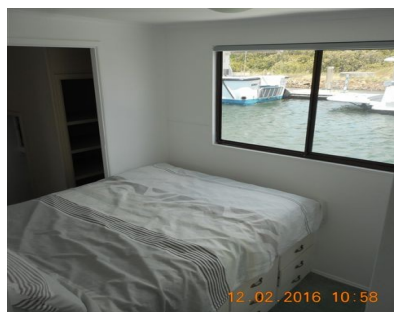
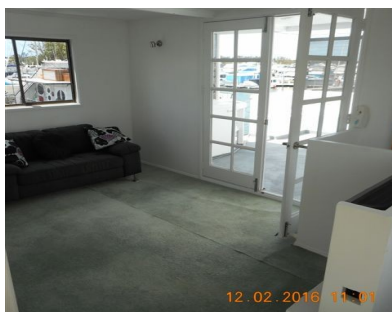
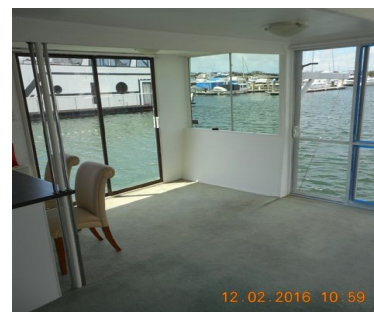
General Condition	:	Good Overall condition
Structure and Scant-lings	:	Good Condition
Timber Work & Bright Work	:	Good Condition
Bulkheads	:	Sound
Bulkhead Connections	:	Sound
Cabin Soles	:	Good Condition
Windows	:	Aluminium Framed Sliding & Fixed Panels
Portholes	:	N/A
Doors	:	Good Condition
Cupboards and Compartments	:	Good Condition
Latches and Hinges	:	Good Condition
Upholstery & Carpets	:	Carpets To Be Replaced Furniture Acceptable
Accommodation Layout	:	1 x Double Berth Cabin / 1 x Single Berth Cabin
Galley Layout	:	S/Steel Sink / Bench-tops and Storage & Cooking Facilities
Lighting	:	240 VAC Throughout
Comments & Recommendations	:	Vessel interior is in an acceptable condition with refurbishment works being carried out. The quality of the refurbishment works is to a good standard.

N/B - It was noted that the internal stairwell does not have grab rails or a hand rail fitted. It is recommended by the undersigned surveyor to install hand-railing onto the lower portion of the interior stairwell and a grab rail to the entrance of the stairwell from the top.
