Crane**Safe**®

AC A 153036-11

### Franna 4WD-MAC14

## ARTICULATED MOBILE CRANE

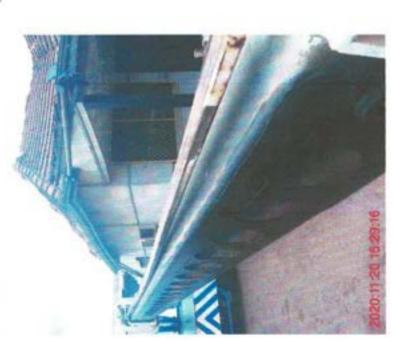
No. 3 Section Push bar is bent

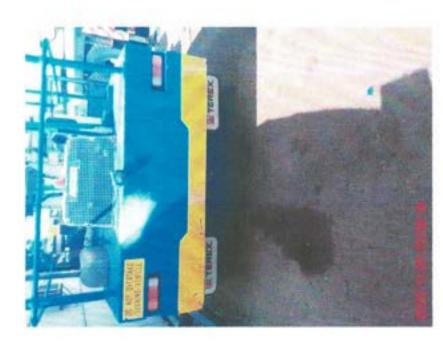
Counterweight Hazard Striping Faded

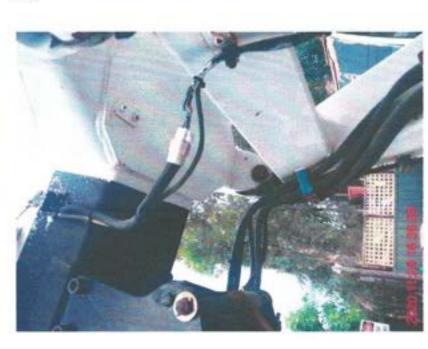
Boom Mounting Pins Noisy when booming up

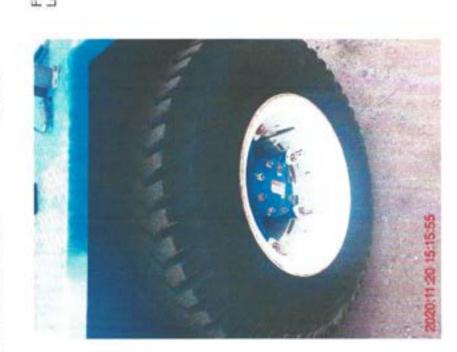
Front Wheels and Tyres Low pressures

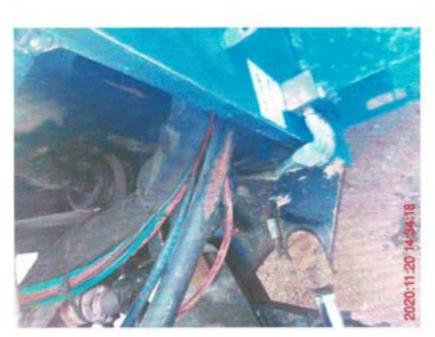
Flow Control Valves Oil leak from valve bank under cabin

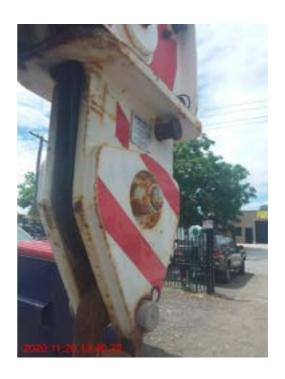
Item Inspected AS1418.5-2013 Annex K.1				
	MANUFACTURERS ID no.	BP11060996		
Fall Block	NOMINAL LIFTING LOAD	7500kg		
	MASS	71kg		
AS1418.5-2013 Annex K.3				
Sheave	NUMBER OF SHEAVES	1		
	ROPE DIAMETER	13mm		
	KIND OF MATERIAL	Metal		
	GROOVE WEAR	¥		
	BRUISING	✓		
	ROTATING / BEARING	✓		
	CRACKS	₹		
	CHIPS	✓

At time of Inspection, the hook block was in accordance with the requirements of AS1418 Part 5 2013 and the load charts supplied with the crane.

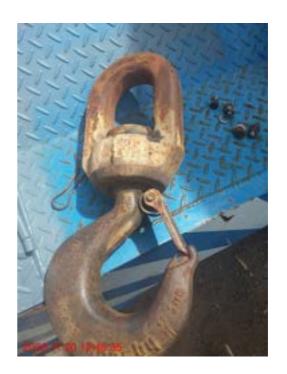
Item Inspected AS1418.5-2013 Annex K.1			
	MANUFACTURERS ID no.	CCE 2071	
Hook	FORM OF HOOK	Single	
Block	NOMINAL LIFTING LOAD	15000kg	
	MASS	0kg	
AS1418.5-2013 Annex K.2			
	WEAR	ightharpoons	
	CRACKS	$\mathbf{Z}$	
	DEFORMATION	$\mathbf{Z}$	
Lifting	SAFETY LATCH	$\mathbf{Z}$	
Hook	SWIVEL	$\mathbf{Z}$	
	BEARING	$\mathbf{Z}$	
	HOOK BRUISING	ightharpoons	
	Y - Y MEASUREMENT	100mm	
AS1418.5-2013 Clause 4.2.13

At time of Inspection, the hook block was in accordance with the requirements of AS1418 Part 5 2013 and the load charts supplied with the crane.
