DISCLAIMER: Second-Hand Plant Condition and Safety

Used Sale Safety & Compliance Check

MHE-000122 / 124195 / Wayne Klein / 24/12/2025 / Jungheinrich /
EFG218K

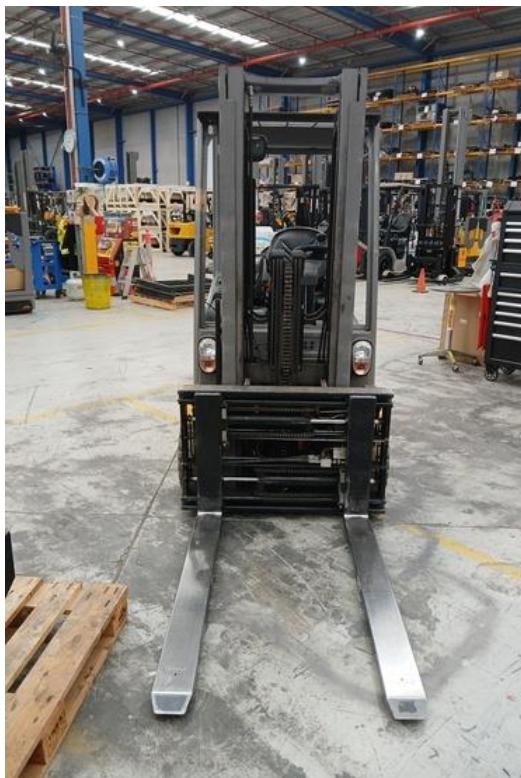
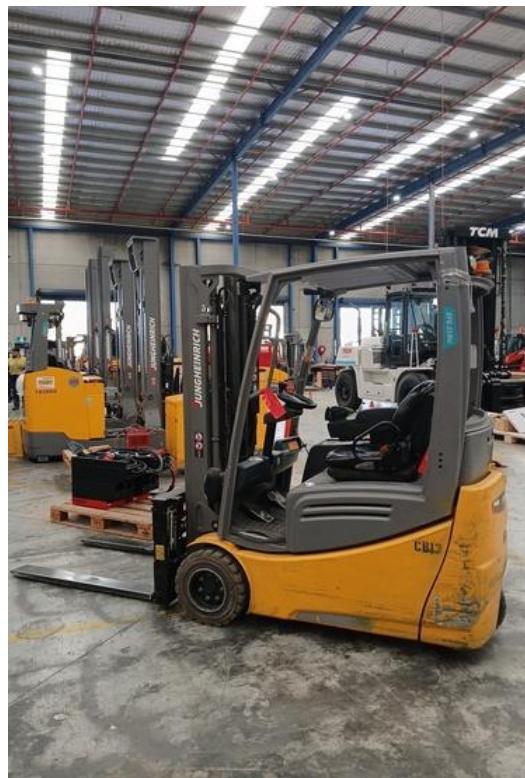
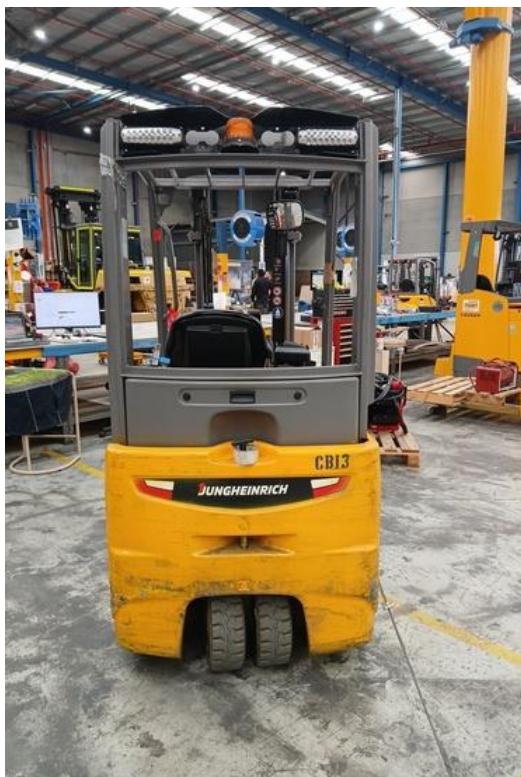
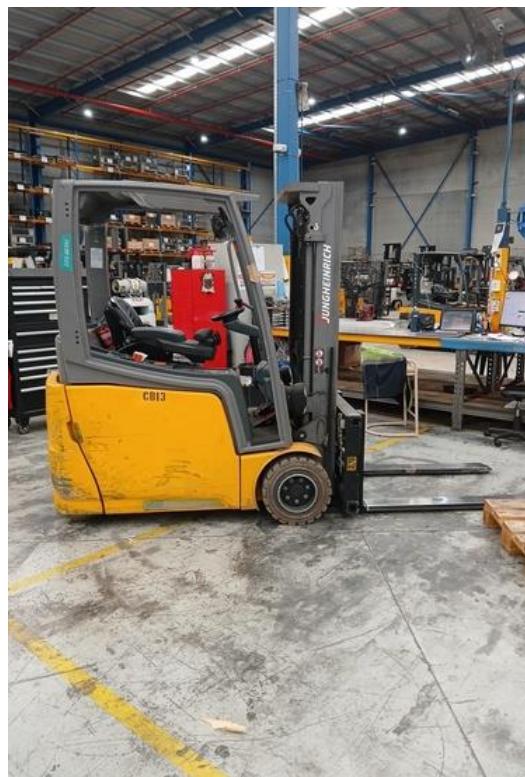
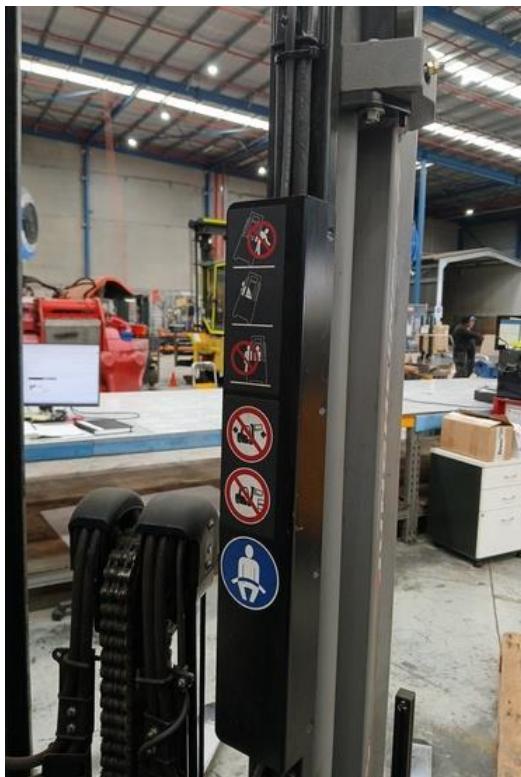
Include Images of the Front, Rear & Sides of the Unit

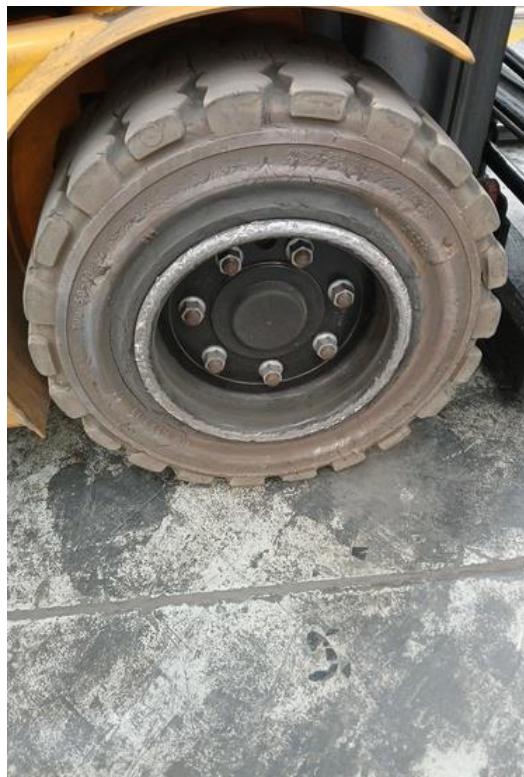
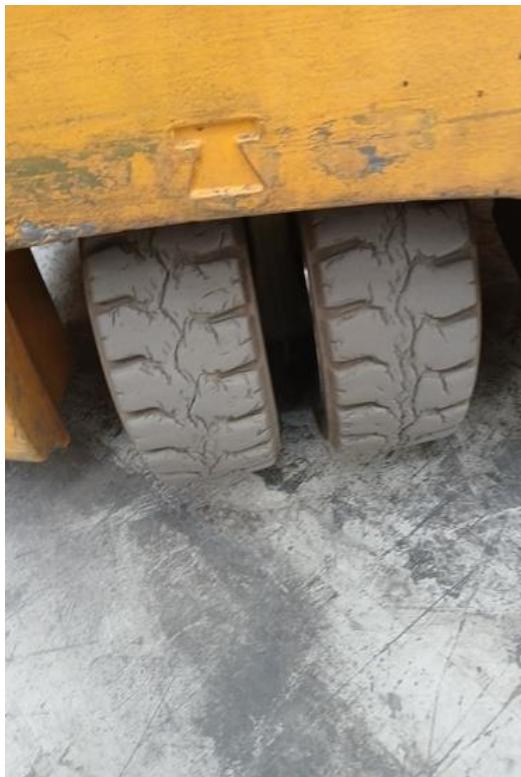
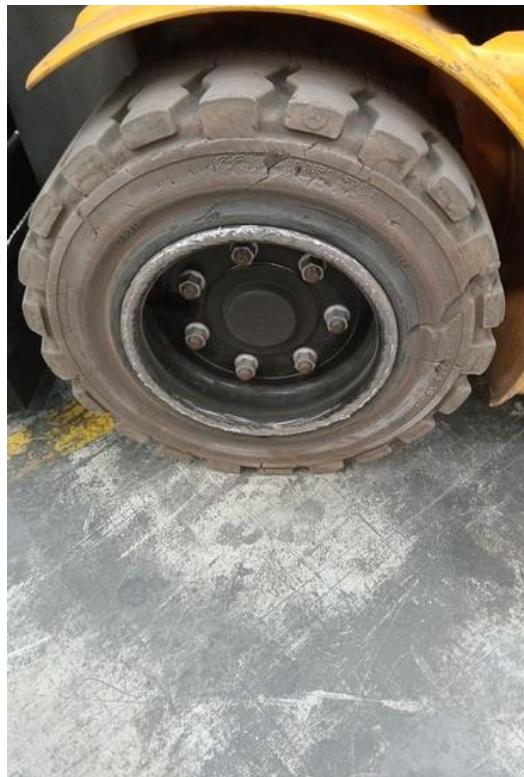
Truck Category	Category 3 - Electric Counterbalance	
Emergency Stop, Horn/Warning device, lights, reverse alarm and flashing lights operational	Yes	
LHS FR PARK LIGHT OUT		
Seat switch and seat belt switch fitted to check presence of operator & working in sequence?	Yes	
Seat is secure and seat belt is in serviceable condition?	Yes	
Mast switch operation for travel speed reduction to 3kmh above specified height	Yes	
Are brakes and park brake functioning correctly?	Yes	
Are tyre treads within limits and/or free from damage? Some cracks	Yes

Photo 6	Photo 7	Photo 8
Are fork tynes in good condition and within specification?	Yes

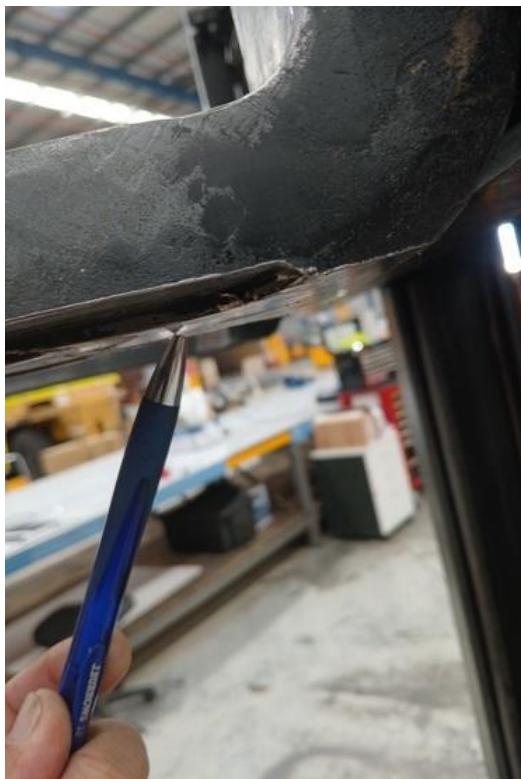
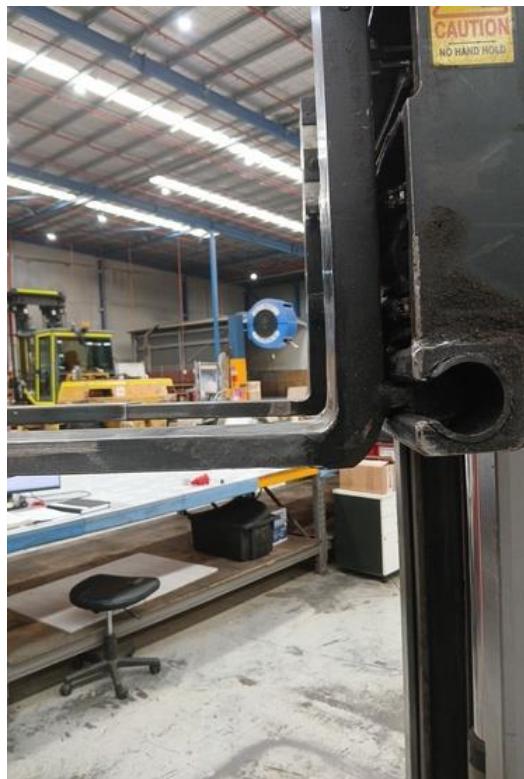
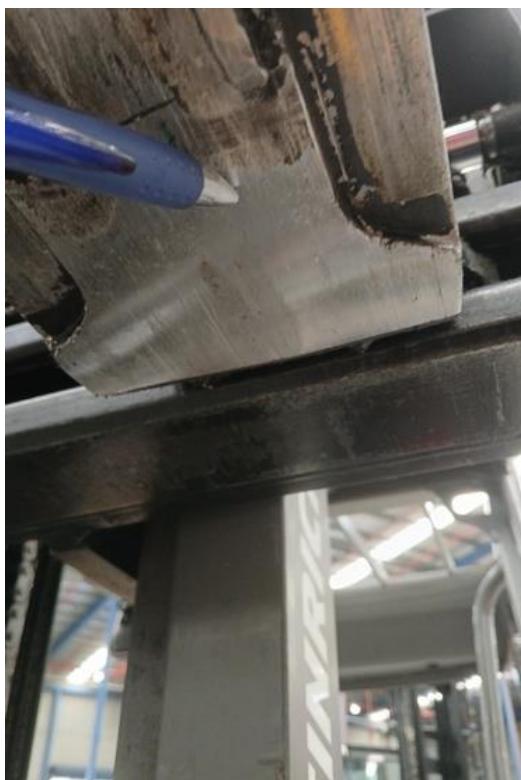
Photo 9	Photo 10	Photo 11
Are mast chains in good condition, within specification and working correctly? 2 3/4% wear - replacement required	No

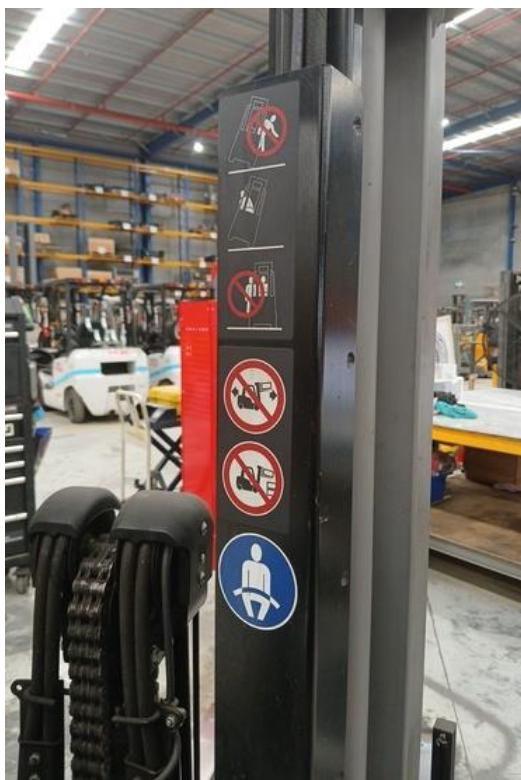
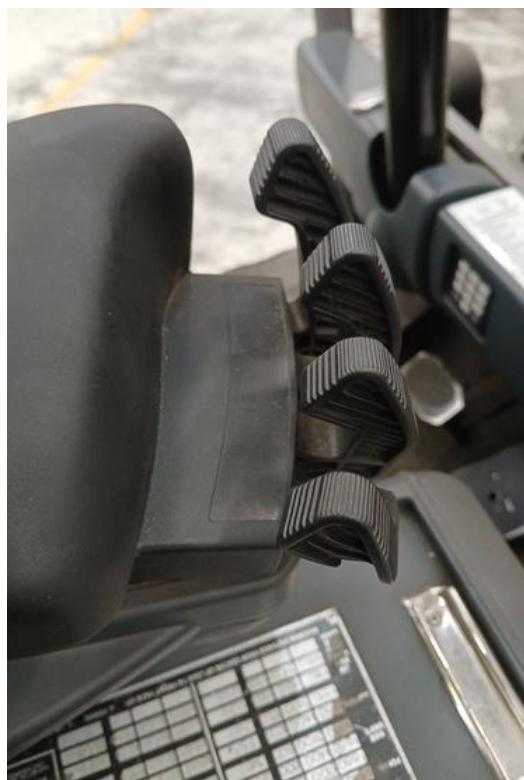
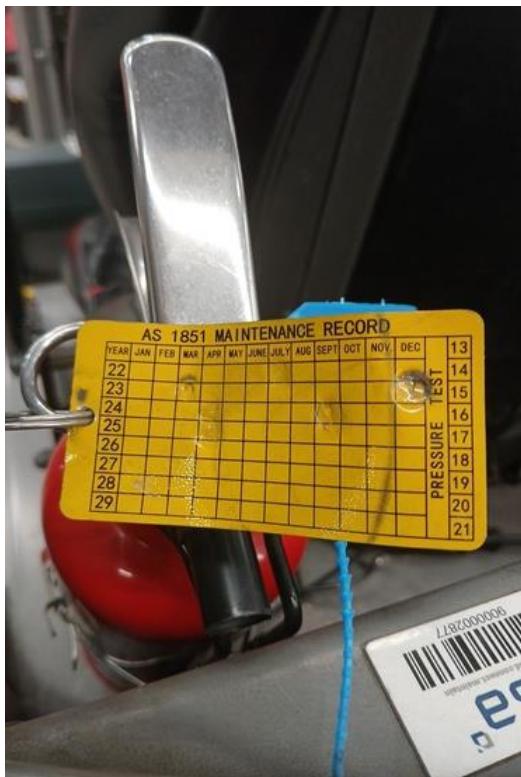
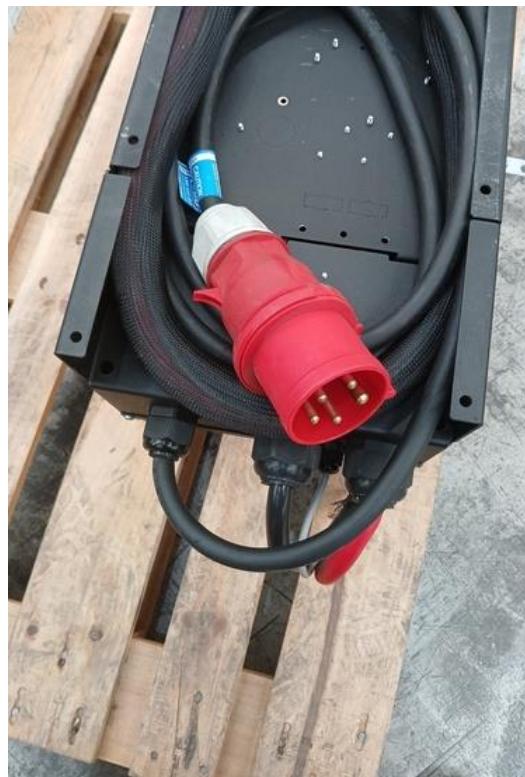
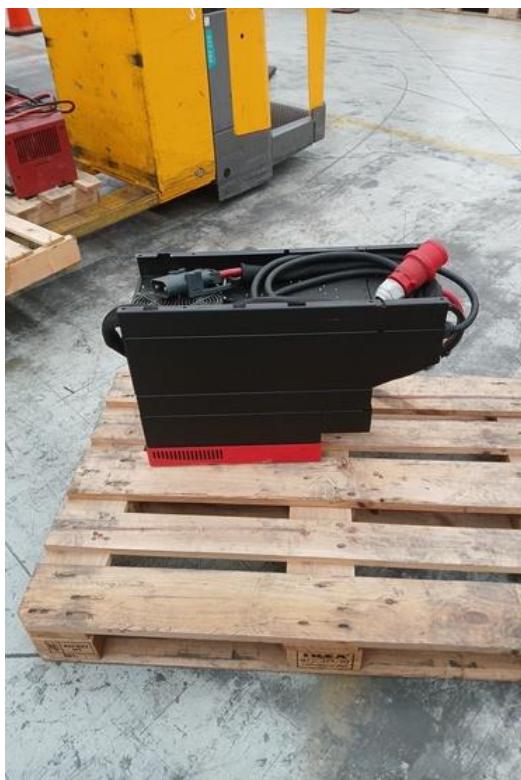
Charger not tested, Fitted with euro plug.

Forklift fitted with aftermarket battery

Mast decal does not have seat belt interlock depiction, missing decals on finger lever operations lift tilt etc.. fire extinguisher due for inspection.
