Pre Sale Vehicle Inspection Report

This report was compiled for
CUSTOM FLEET

| Make HOLDEN | Model HOLDEN VE P/CAR | | |
| Badged OMEGA | Registration Number CRA161 | State Registered N.S.W. | Expiry / Date on label 24/06/2012 |

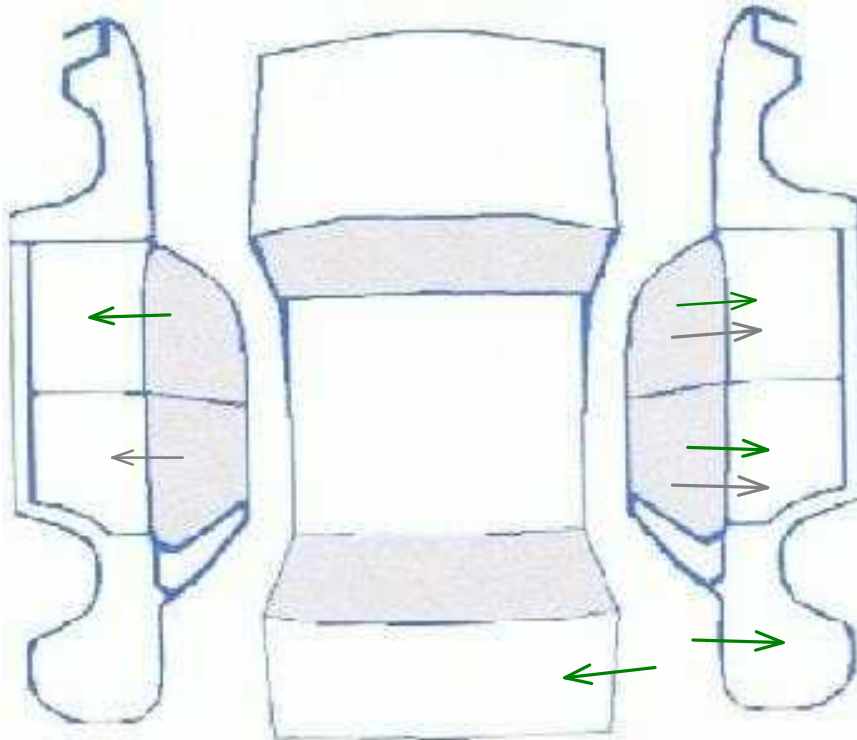
Cosmetic Refinish = Green
 Minor Scratches or Dents = Grey
 Damage / Larger Dents = Black
 Previous Body repairs = Pink
 Rust = Red

Vehicle has had superficial panel and paint repairs to various panels- No evidence of any chassis or structural repairs found refer diagram<>
 Minor dents/chips/scratches to various panels<>
 Minor scuff marks/dents at bumpers and side panels<>
 Minor stone chips to paint work on panels<>
