## Used Sale Safety & Compliance Check

MHE-000021 / 129133 / Melbourne Service / 01/09/2025 /  
Jungheinrich / EFG 320

| Model | EFG 320 |

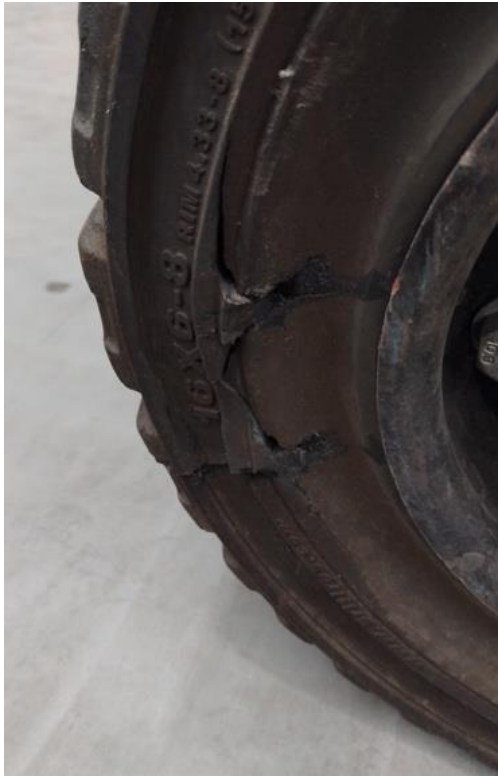
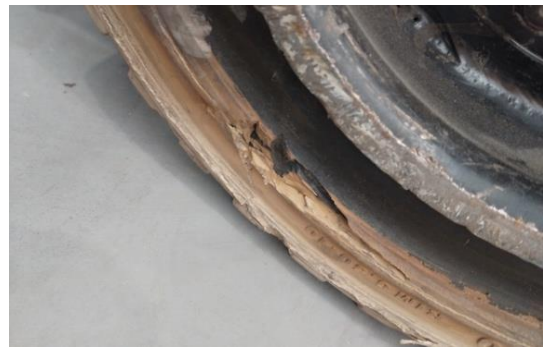
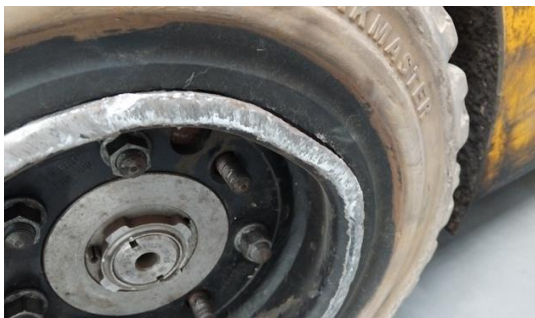
| Observations Summary | |
|---|---|
| <b>Are tyre treads within limits and/or free from damage?</b> | No |
| <div> </div> <div> <div>Photo 5</div> <div>Photo 6</div> <div>Photo 7</div> </div> | |
| <b>List any other notable defects or faults e.g. ROPS/FOPS damage etc.</b><br>Tires missing chunks, front rim bent | |
