PRE-PURCHASE SURVEY FOR

19/10/2022

DREW SAYER
FORE AND AFT SURVEYORS
PH: 0419 042 558 ABN 95806 164059
WWW.FOREANDAFTSURVEYORS.COM
GLENWOOD QUEENSLAND 4570

VESSEL: Foxy Lady **DESIGN:** Mariner 31 **REGISTRATION:** DL103Q

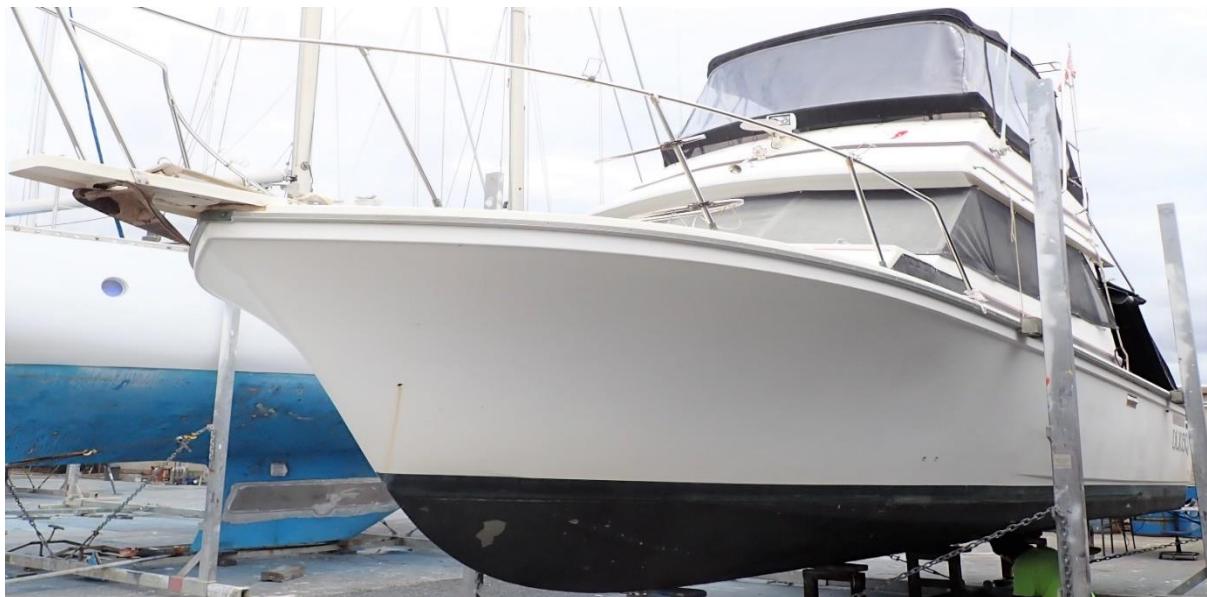
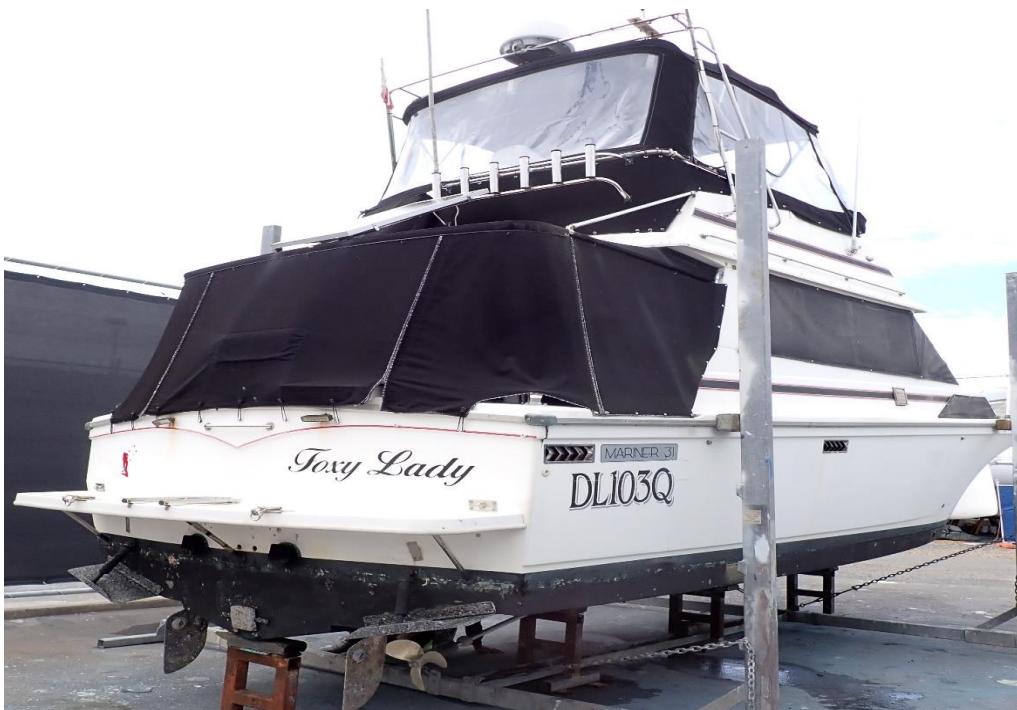
LOA: 9.45 meters **BEAM:** 3.5 meters **DRAFT:** 0.8 meter **BUILT:** 1984

CONSTRUCTION: Fiberglass hull and cabin **ENGINE TYPE:** Twin Mercruiser inboards
