## **SURVEY REPORT**

At the request of John Dutch (Client)  
of 4 Idlewoods Cr. Rainbow Flat NSW 2430, RMS carried out an 'out of  
water' pre purchase condition survey, at Marks Point Marina (Location of  
vessel) on 10<sup>th</sup> November 2021 (Date of inspection).

<b>Name:</b>	<b>Ambassador 1</b>
<b>Model:</b>	<b>Gulf Craft Ambassador 38</b>
<b>Hull material:</b>	<b>GRP</b>
<b>Hull colour:</b>	<b>White</b>
<b>Designer:</b>	<b>Gulf Craft</b>
<b>Builder:</b>	<b>Gulf Craft</b>
<b>Launched:</b>	<b>1995</b>
<b>LOA:</b>	<b>11.6m</b>
<b>Beam:</b>	<b>3.7m</b>
<b>Draft:</b>	<b>.9m</b>
<b>Displacement:</b>	<b>Approx 5.5 tonnes</b>
<b>Registration/HIN #</b>	<b>AUWWA159144HT8</b>
<b>Waterways #</b>	<b>AFG898N</b>

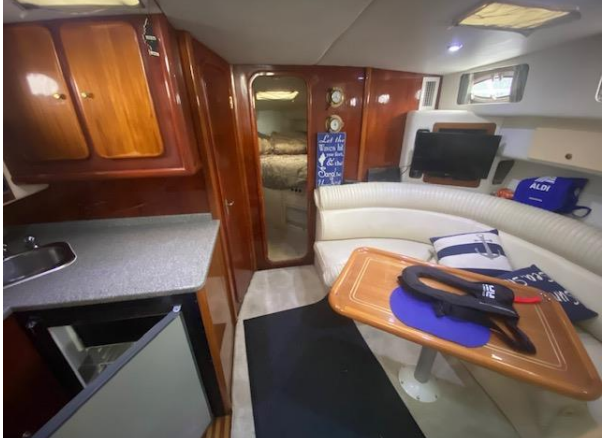
<b>1. Interior view looking forward</b>	<b>2. Galley</b>

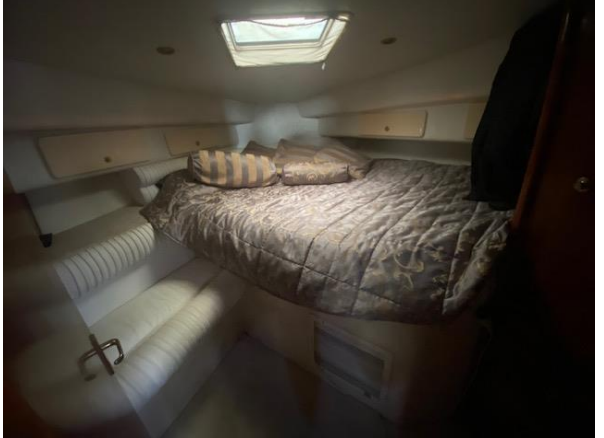
A photograph of the aft cabin, showing a bed with a patterned blanket and a window. The cabin is finished with wood paneling.
<b>5. Forward cabin</b>	<b>6. Water damage port side</b>

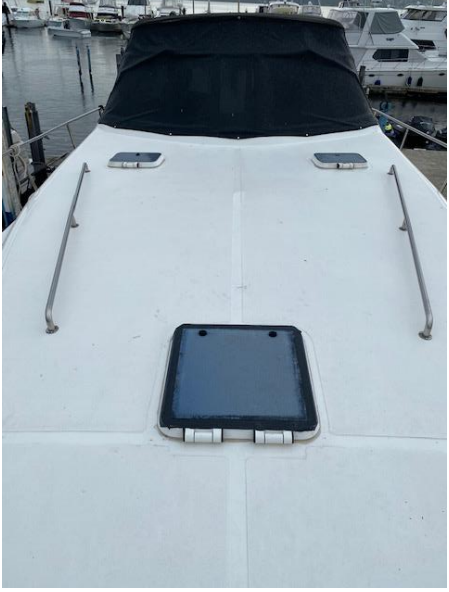
<b>19. Foredeck, spotlight &amp; ground tackle</b>	<b>20. Foredeck</b>
