## ULTRASONIC THICKNESS TESTING

| <b>Order No / Req:</b> | 017510 | <b>Report No.:</b> | UTT01 - 662 - Rhinos Diesel Services |
| <b>Test Description:</b> | Thickness testing on vessel SN: AP 750 03806 | | |

Vessel SN: AP 750 03806

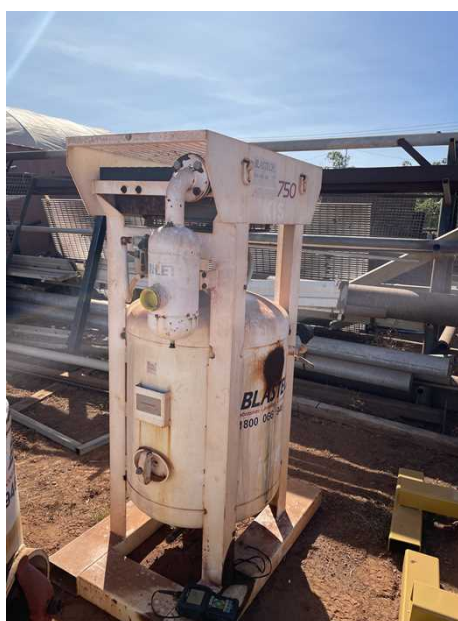
| <b>Surface Preparation:</b> | None | <b>Area of Test:</b> | As shown in drawing bellow |

Overview of vessel

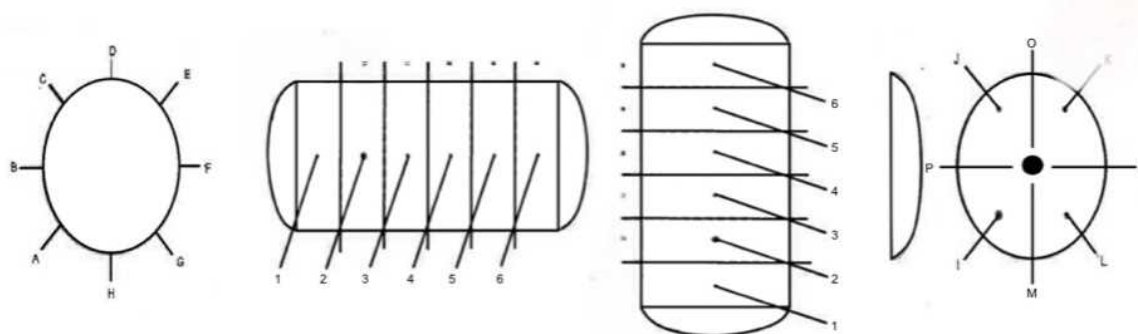
| | 1 | 2 | 3 | 4 | 5 | 6 |
| <b>A</b> | 6.3 | 6.3 | 6.0 | 6.1 | 6.4 | 6.1 |
| <b>B</b> | 6.2 | 6.3 | 6.0 | 6.0 | 6.1 | 6.2 |
| <b>C</b> | 6.1 | 6.0 | 6.3 | 6.2 | 6.2 | 6.3 |
| <b>D</b> | 6.0 | 6.1 | 6.2 | 6.3 | 6.2 | 6.1 |
| <b>E</b> | 6.3 | 6.2 | 6.1 | 6.1 | 6.2 | 6.0 |
| <b>F</b> | 6.2 | 6.0 | 6.3 | 6.0 | 6.3 | 6.1 |
| <b>G</b> | 6.1 | 6.3 | 6.2 | 6.0 | 6.1 | 6.2 |
| <b>H</b> | 6.1 | 6.2 | 6.4 | 6.2 | 6.0 | 6.3 |
| <b>Dome</b> | Top | Bottom | | | | |
| <b>I</b> | 5.9 | 5.9 | | | | |
| <b>J</b> | 5.8 | 6.0 | | | | |
| <b>K</b> | 5.9 | 6.1 | | | | |
| <b>L</b> | 6.1 | 6.0 | | | | |
| <b>M</b> | 5.6 | 5.9 | | | | |
| <b>N</b> | 5.8 | 5.7 | | | | |
| <b>O</b> | 6.0 | 6.1 | | | | |
| <b>P</b> | 5.9 | 5.8 | | | | |
